Keystone RV Company

SERVICE ADVISORY # 20-387

Bullet Front Caps

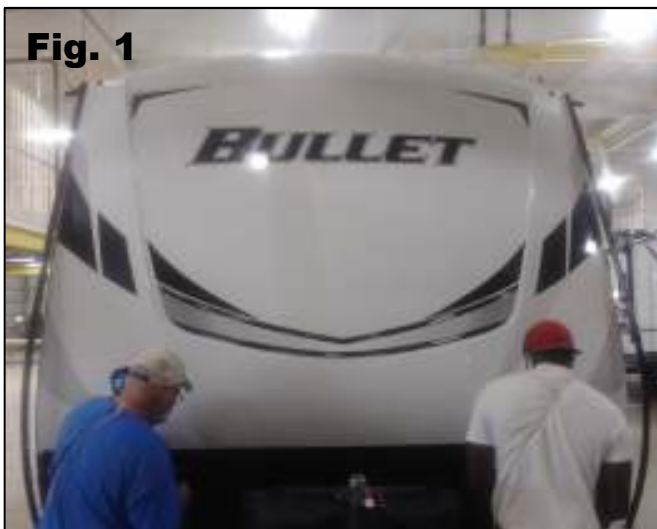
Unscrew both front corner moldings to the top of the front wall at the bend, Figure 1. Remove the floor line molding along the front lower metal on the front cap. Be sure to score (cut) the cap seal along the sidewalls to prevent any of the moldings bending. Do not remove any of the moldings on the roof of the unit. Do not remove the lower front wall metal, Figure 2.

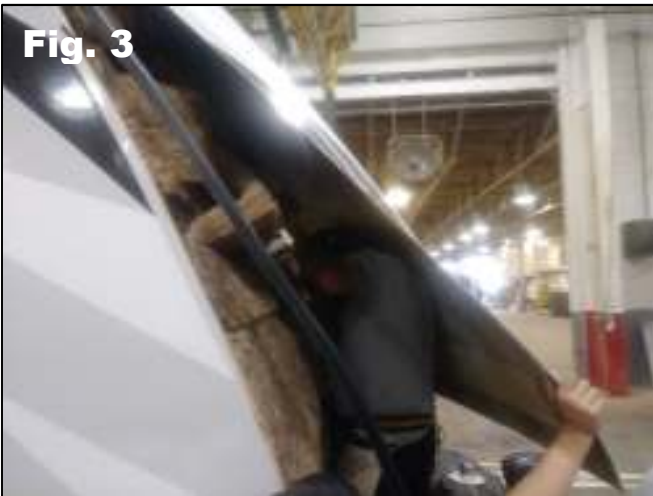
Fig. 3

Pivot cap upward and brace providing access to the front wall aluminum cage (will require 2 people to hold cap), Figure 3.
